Twin Commander Aircraft, LLC

Maintenance Alert

Ref MA23001

SUBJECT: INSPECTION FOR CRACKS IN LOWER WING SKINS AROUND MLG TRUSS CUTOUTS.

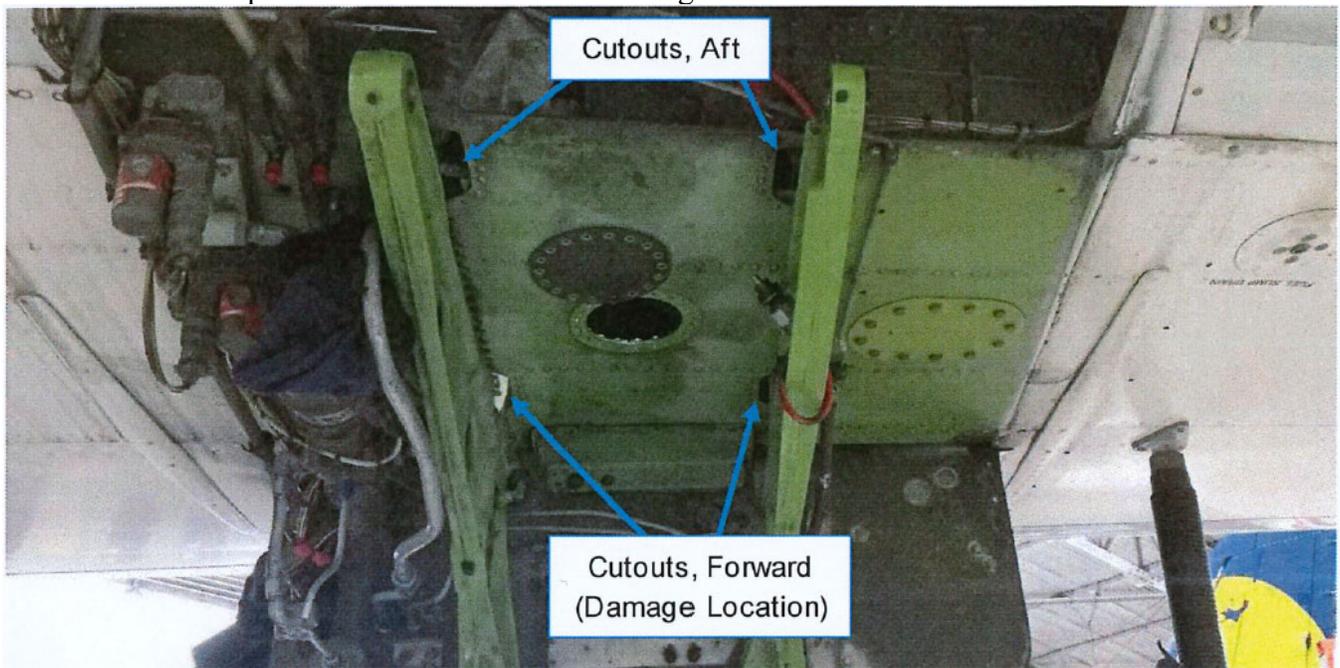
5. In addition, perform either,
 - 1) HFEC inspection of the cutout radii following the procedure laid out below,
 - a. HFEC Procedure: Perform High Frequency Eddy Current, on the lower wing skin – both inner and outer skins, and around the entire cutout edge, at the FWD MLG Truss cutouts (see Figure 1). Min detectible flaw length is 0.050” long. Skin alloy is Aluminum Alloy 2000 Series.

Figure 1, View looking forward and slightly up.

- b. Removal of the lower wing access door inside the nacelle may also aid in accessing the cutouts (Figure 1).
3. If cutouts are filled with sealant, carefully remove sealant, using plastic scraper and tools, around FWD and AFT radii of cutout to gain access to edge of cutouts. Clean area and edges of skins.

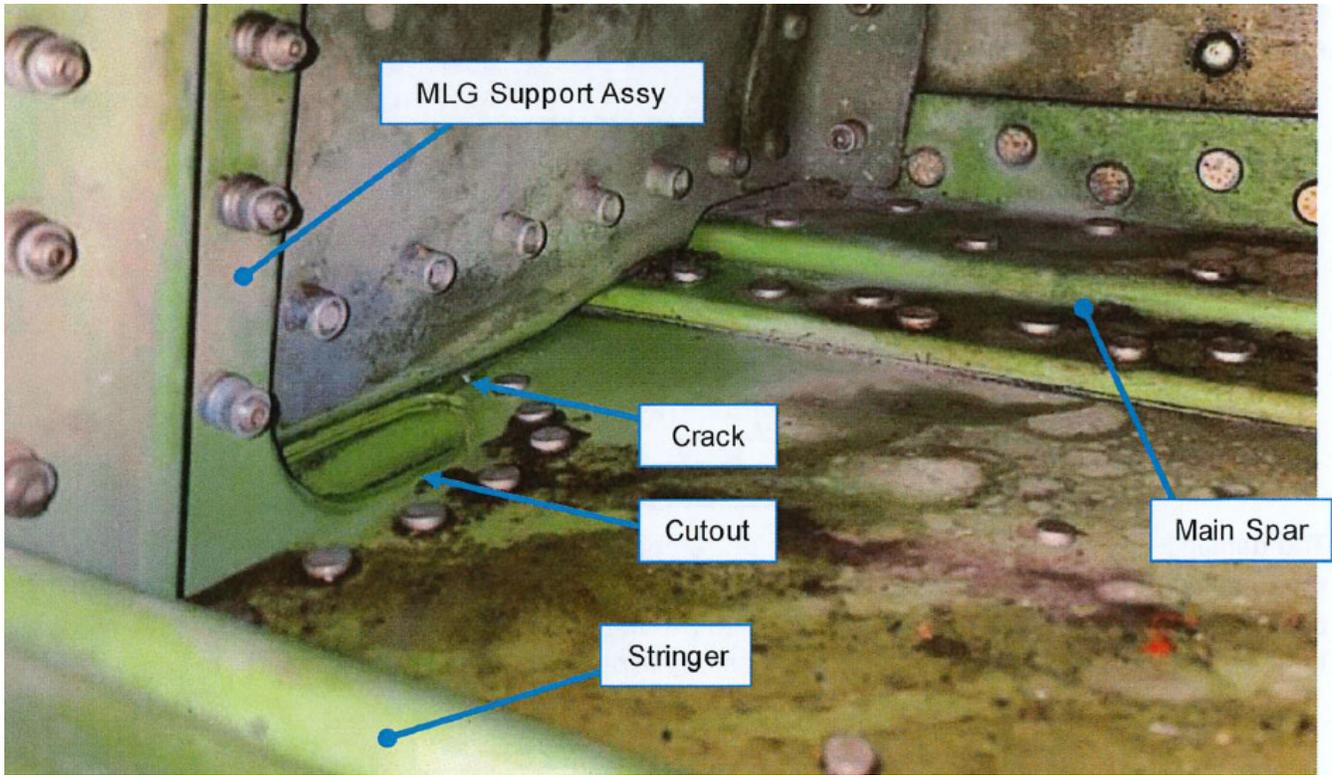
REASON FOR PUBLICATION: Two reports from the field noted small cracks extending forward and aft from the radii of the lower wing skin cutouts in each nacelle for the FWD portion of the MLG Truss. This Alert is to highly recommend detail visual inspection and either high frequency eddy current inspection (HFEC), or liquid penetrant inspection (LPI) of the lower wing skin at the FWD cutout areas, and to request feedback post inspection to help Twin Commander Aircraft in determining the prevalence of cracks in these locations.

4. Visually inspect the cutout area for cracks using good light (min 100fc). If possible, take photos of noticeable cracks and include these photos with your compliance card, which can be mailed or emailed to the address shown. See Figure 2 for typical crack locations.

Figure 2. View inside the nacelle, looking forward and slightly down (crack propagating forward of FWD cutout radius towards front spar).

- 2) Liquid Penetrant Inspection (LPI) per ASTM E1417 the inner and outer skin surfaces, for cracks. For LPI, the skin surfaces must be stripped of surface finish. Acceptance Criteria per MIL-STD-1907, Grade A.
6. If cracks are found, contact Twin Commander Aircraft, LLC at the address below, and report findings on compliance card.
