Twin Commander Aircraft, LLC

Maintenance Alert

HOW TO IDENTIFY “HEAVY” MAIN LANDING GEAR

Ref MA24002

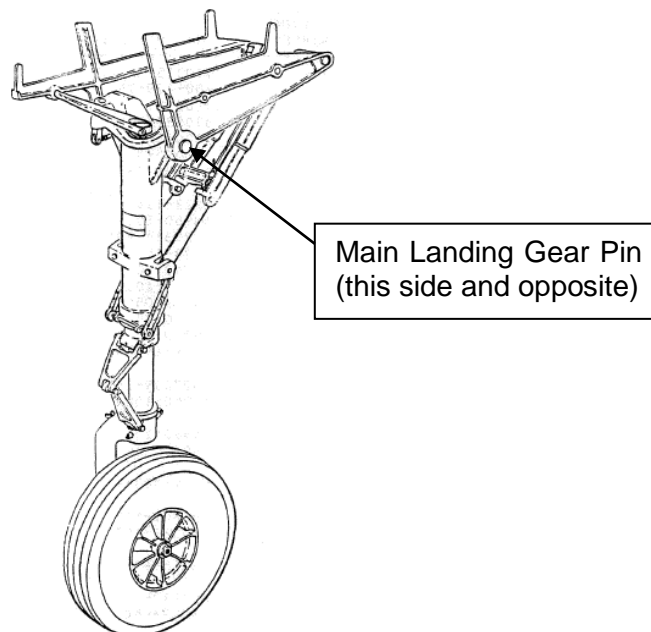
Figure 1

1. Perform an inspection of the Outboard MLG Pins, on the LH and RH sides of the aircraft. See **Figure 1**.
2. Higher Gross Weight MLG will have a longer outboard MLG pivot pin (P/N 730083-1). The Pin Shaft Lengths (below), excluding the pin head length. The Pins may be marked with a P/N; however, the part marking may have been burnished off the part.
 - a. Short Pin, P/N ED12496-1, length 3.30
 - b. Long Pin, P/N 730083-1, length 3.50

Heavy Gross Weight MLG pin when installed on an aircraft not certified for Heavy Gross Weight MLG will result in the outboard MLG pin heads protruding proud of the MLG trunnion or may be shimmed to take-up the extra length.
